# TECHBRIEF

## Traffic Calming on Main Roads Through Rural Communities

FHWA Publication No.: FHWA-HRT-08-067

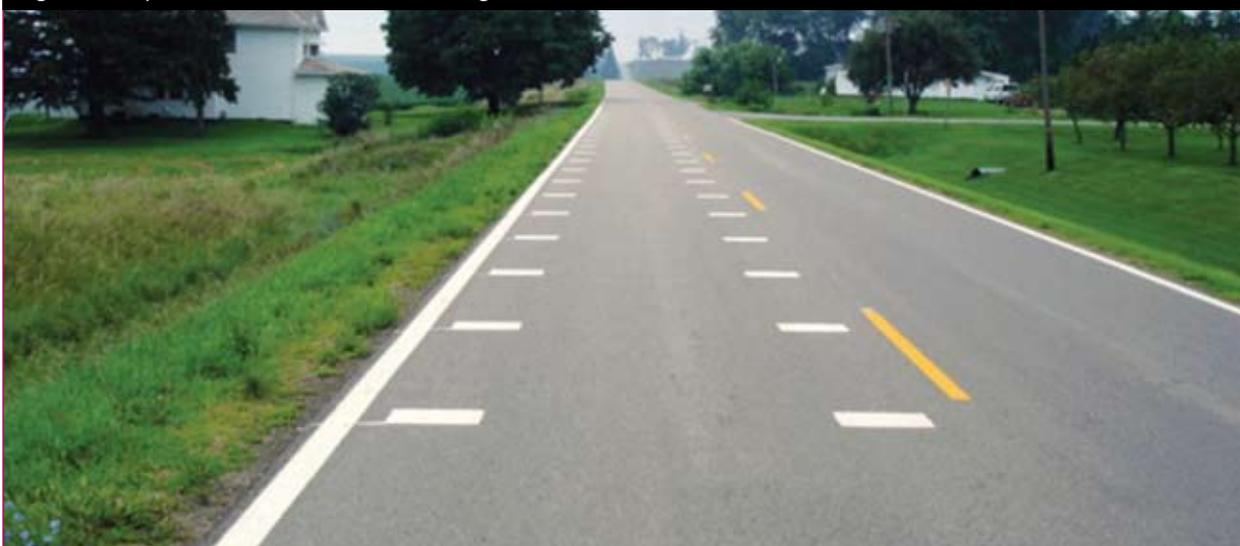
Figure 1. Experimental transverse markings at entrance to Union.

The transverse markings consisted of a series of parallel bars on the inside edges of the travel lane. The spacing between bars decreased approaching the community. The series of markings are intended to create the perception that the vehicle's speed is increasing to trigger driver awareness of the need to slow down. The transverse markings were 12 inches wide (parallel to roadway edge) by 18 inches long (figure 1). The markings were installed at the north, south, and west entrances to the city of Union. Markings were placed in advance of and terminated at the speed limit sign which established the speed within the community. The length of each series and distance between bars varied based upon each speed transition and location within the series.

speed by location and observation period. For the south entrance (U5) where transverse markings were the only treatment installed, there was little change in prevailing speed. Similar results were found for southbound traffic entering the north side of town (U2) and eastbound traffic entering from the west (U1) prior to the installation of speed feedback signs.

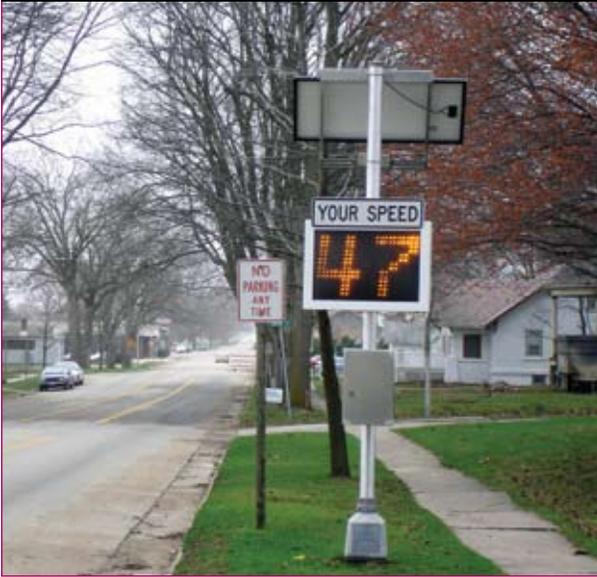
Figure 2. Speed feedback sign in Union.

Speed feedback signs (figure 2) were also installed within Union. These signs consisted of a static "Your Speed" sign and an electronic display of the approaching vehicle speed measured by radar. These signs were installed for inbound motorists at the north and west city entrances and were placed immediately downstream of the transverse markings as shown in figure 3. Due to purchasing and installation problems,

After the feedback signs were installed, speeds dropped an additional 3 mi/h to 6 mi/h at the north and west entrances during the 9- and 12-month analysis periods. Since the signs were only in place for a short period of time, it is not known if the observed speed reductions persisted over the longer term.

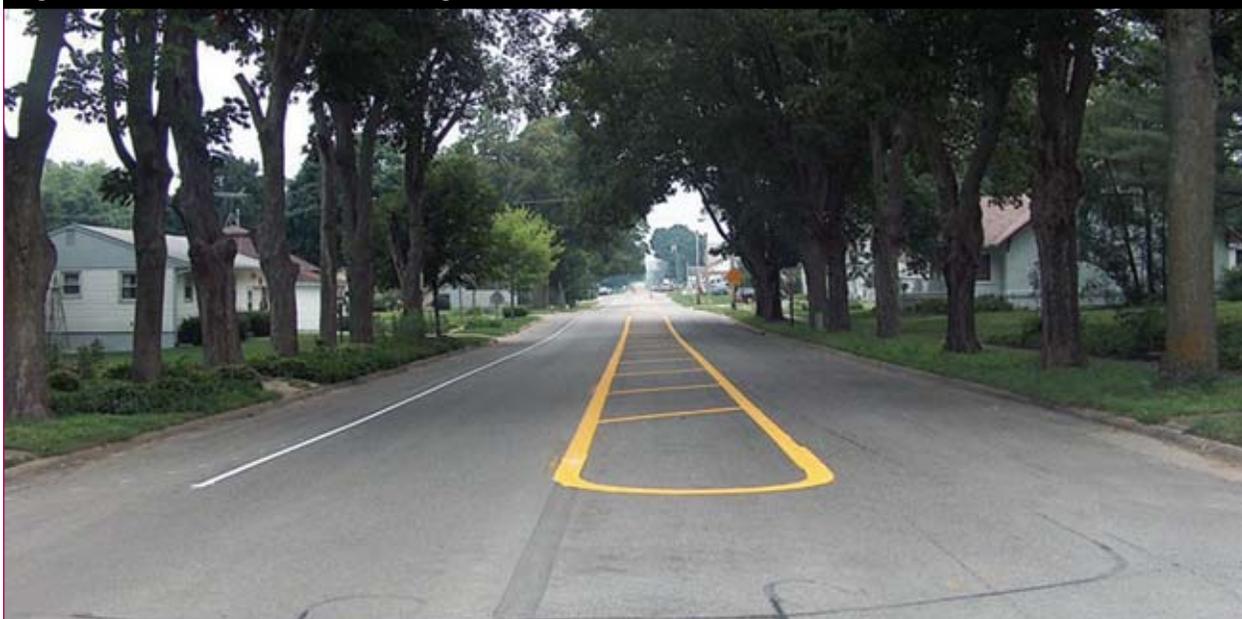
Figure 4. Painted center island and edgeline used to narrow lane.

Median and shoulder pavement markings shown in figure 4 were used to reduce lane

widths for a section of S-62/SH 215 within Union. The existing two-lane roadway was 40 ft wide from curb to curb with parallel parking allowed on one side. A 10-ft-wide painted center island was used to reduce the existing lane widths from roughly 16 to 11 ft in each direction. A solid 6-inch channelizing line was painted to separate the

travel lane from an 8 ft parking lane. Drivers were expected to slow down due to feeling constrained by narrower lanes.

No consistent changes in 85th percentile speed were observed for either direction. In some cases, vehicle speeds decreased; in other cases, vehicle speeds increased. The variability in speeds suggests that the treatment was not effective and that other factors may have influenced speeds. Speed data collected at a point upstream of the north section where vehicles were not influenced by any of the traffic-calming treatments exhibited an overall upward speed trend. This suggests the observed increases in speed were due in part to general time trends.

Even though the roadway was reduced from 16 ft to 11 ft lanes in each direction, the lanes may have still been too wide to affect driver behavior. A more drastic reduction in lane width (e.g., 9 ft lanes) or a physical barrier (e.g., raised curb) may be necessary to produce the desired effect since there are no consequences for driving over the pavement markings.

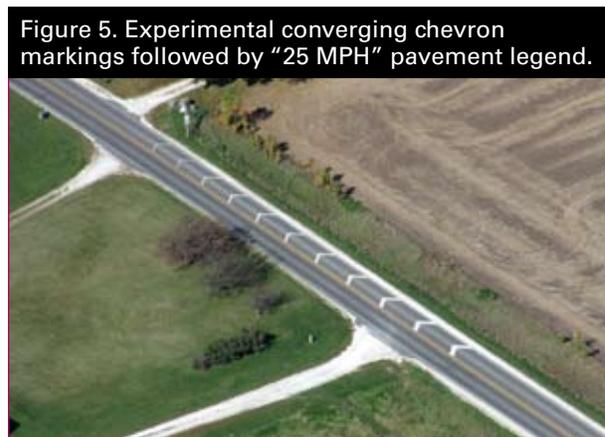
A series of converging chevron markings shown in figure 5 were installed on County Road E-18 on both entrances to Roland. The markings

began 221 ft in advance of and terminated at the speed limit sign which established the speed within the community. The distance between chevrons gradually decreased from 25 ft to 18 ft, and the width of the markings decreased from 36 inches to 6 inches in the direction of travel, giving the perception of increasing speed. The pavement marking legend "25 MPH" was installed at the end of each chevron series to reinforce the posted speed.

As shown in table 4, the 85th percentile speed decreased up to 4 mi/h, while 1 mi/h was more typical for the various analysis periods. Although the chevron markings were somewhat effective in reducing vehicle speeds, prevailing speeds were still 7 mi/h to 9 mi/h above the posted speed limit 12 months after implementation.

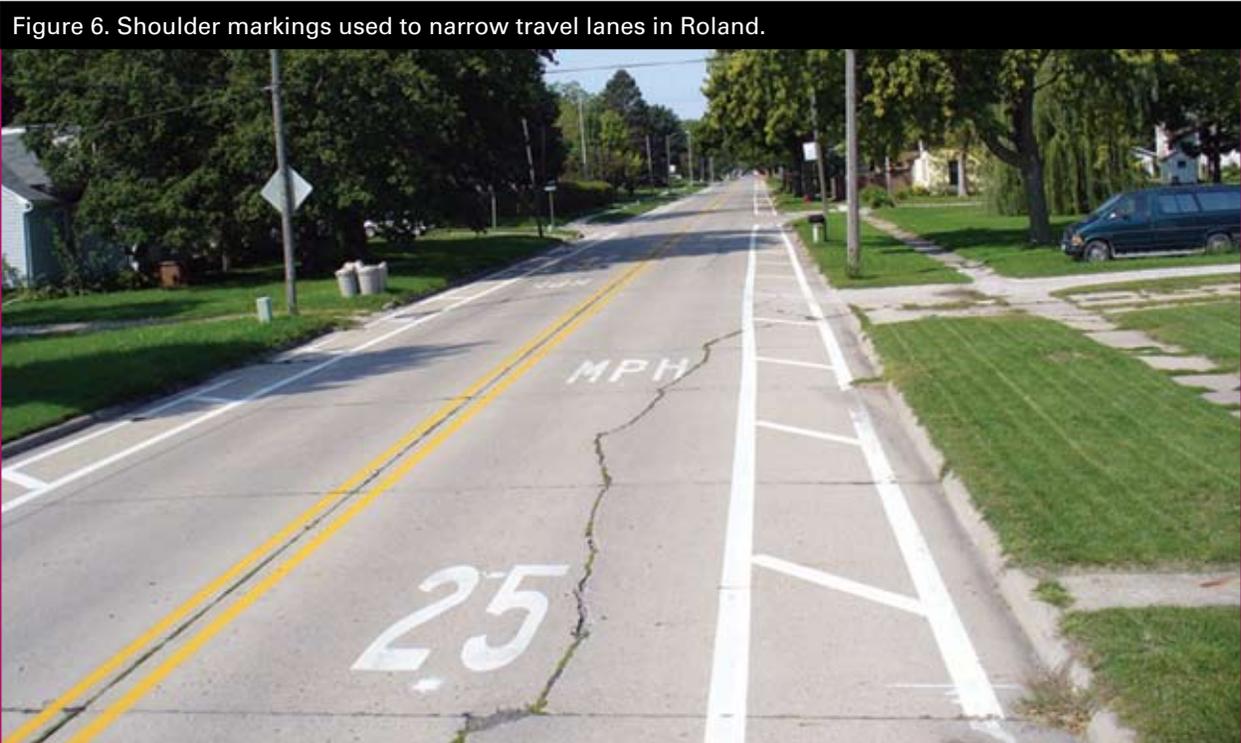
A wide edgeline and cross-hatch markings, as illustrated in figure 6, were used to create a shoulder on both sides of the roadway and reduce lane widths for a section of E-18 within Roland. The existing two-lane roadway was 36 ft wide from curb to curb. The painted shoulders reduced the lane width to 10.5 ft in both directions. The narrow lane was intended to make drivers travel

slower due to feeling constrained. White pavement marking legends indicating “25 MPH” were placed at regularly spaced intervals within the narrowed section to remind drivers of the speed limit.

Data were collected at the midpoint of the narrowed section. As shown in table 5, the lane narrowing and speed limit markings were not effective in reducing vehicle speeds. There were no consistent changes in the 85th

Even though the eastern section of E-18 was reduced from a 36 ft cross-section to 10 ft lanes, the lanes may have still been too wide to affect driver behavior. A more drastic reduction in lane width (e.g., 9 ft lanes) or a physical barrier (e.g., raised curb) may be necessary to produce the desired effect since there are no consequences for driving on pavement markings.

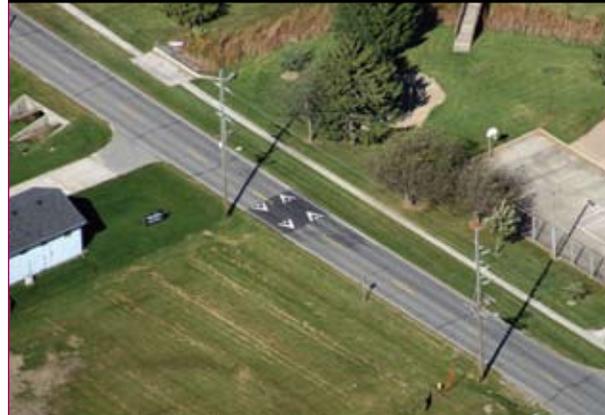
Figure 7. Aerial view of speed table in Gilbert.

A speed table (figures 7 and 8) was installed on County Road E-23 within the center of Gilbert. The two-lane asphalt roadway has grass shoulders, no curb, and a 25 mi/h posted speed limit. The speed table was 3 inches high and 22 ft in the direction of travel, including 6 ft ramps at both ends. The asphalt speed table was designed to be traversed at 30 mi/h to accommodate heavy trucks and farm vehicles.

The speed table was very effective in reducing speeds. As shown in table 6, 85th percentile

speeds were reduced at the hump location by 4 mi/h to 5 mi/h over all “after” periods to within a few miles per hour of the 25 mi/h posted speed limit. Approximately 200 ft downstream of the speed table, speeds were still 4 mi/h

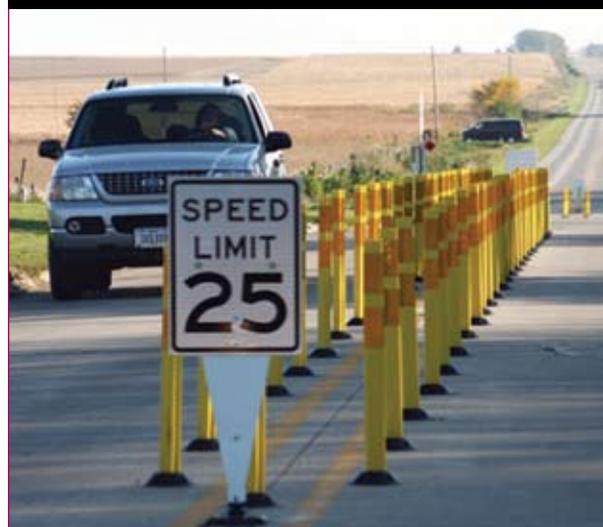
**Figure 9. Tubular channelizing markers used for center island to narrow lanes.**

Tubular markers shown in figure 9 were used to create two center islands along the southern section of R-39 in Slater. At this location, the roadway is 26 ft wide from curb to curb. Center islands were formed by placing two rows of 36-inch-tall yellow tubular channelizing markers to reduce lane widths to 11 ft in each direction. The tubular markers were spaced 4 ft apart in the taper and 8 ft elsewhere. A 25 mi/h speed limit sign was placed on a mountable sign support at both ends of each island. The first island was located at the southern entrance to Slater, just after the first posted 25 mi/h speed limit sign. The second island was located approximately one block north of the first island.

Although the treatment was designed to accommodate agricultural equipment and maintenance vehicles such as snowplows, the markers were damaged during winter operations and were removed for 6 weeks. The markers were reinstalled as soon as no more snow events were expected.

between the two center islands. The data indicate the islands using tubular channelizing markers reduced vehicle speeds; 85th percentile speeds decreased by up to 3 mi/h when the tubular markers were in place and increased up to 4 mi/h when the tubular markers were removed. Similar speed changes were also observed for inbound traffic just downstream of the second island. Even with the speed drop, 85th percentile speeds were still 10 mi/h to 15 mi/h above the posted speed limit.

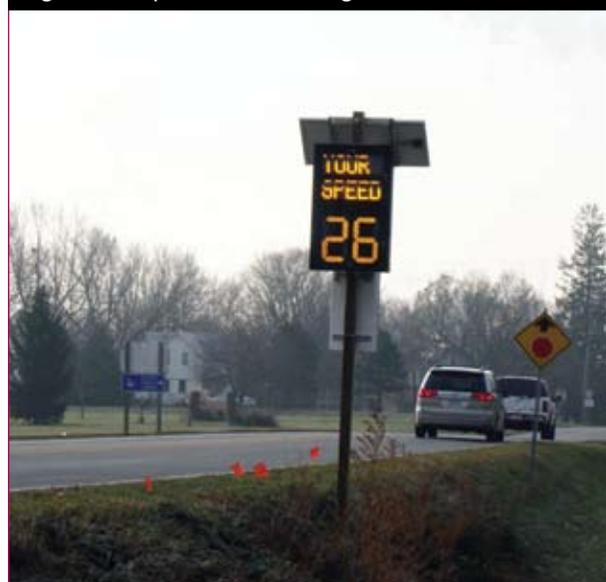
Figure 10. Speed feedback sign in Slater.

A speed feedback sign pictured in figure 10 was

installed on County Road R-38 for inbound traffic at the north entrance to Slater. This section of R-38 is adjacent to an elementary school, has a 25 mi/h posted speed limit, and has a rural cross-section with steep shoulders and open ditch drainage.

The sign display varied based upon vehicle speeds measured via radar. The sign remained blank (black) when no traffic was present or when the approaching vehicle speed was less than or equal to 25 mi/h (or greater than 75 mi/h). Between 26 mi/h and 29 mi/h, the sign displayed the text "Your Speed" along with the measure vehicle speed, as shown in figure 10. For vehicles approaching between 30 mi/h and 75 mi/h, the message "Slow Down 25" was displayed. No other traffic-calming treatments were in place at this location.

The speed feedback sign, when operational, was very effective. Speeds measured just down-

stream of the sign decreased from 37 mi/h to 30 mi/h 3 months after the sign was operational. It is not known if the 7 mi/h speed reduction can be sustained over time.

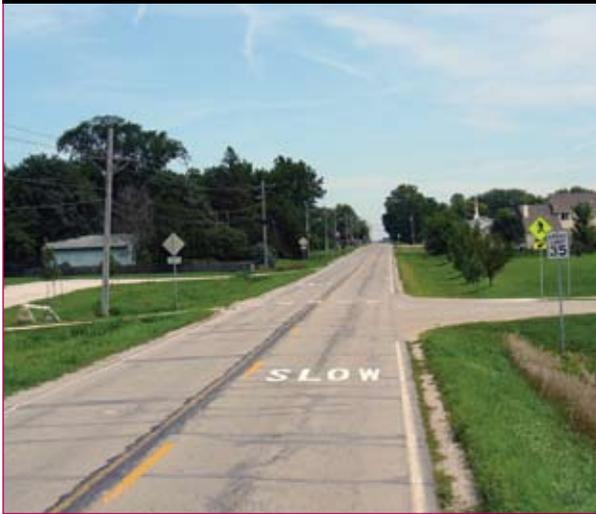
Figure 11. "SLOW" pavement legend in Slater.

Pavement marking legends indicating "SLOW" (as shown in figure 11) were used at two locations along the western section of SH 210 in Slater. The first pavement legend was placed just inside the

western community entrance. At this location, there was a park and a crosswalk that children used to cross to and from school and the park. The second was placed about 1,500 ft downstream of the first location.

The "SLOW" markings were not effective in reducing speeds. As shown in table 8, the 85th percentile speed actually increased for traffic entering Slater just downstream of the first pavement legend. There was little or no reduction in vehicle speed just downstream of the second "SLOW" marking. Data were not collected for the 12-month data collection interval because the road was resurfaced after the 9-month data collection period.

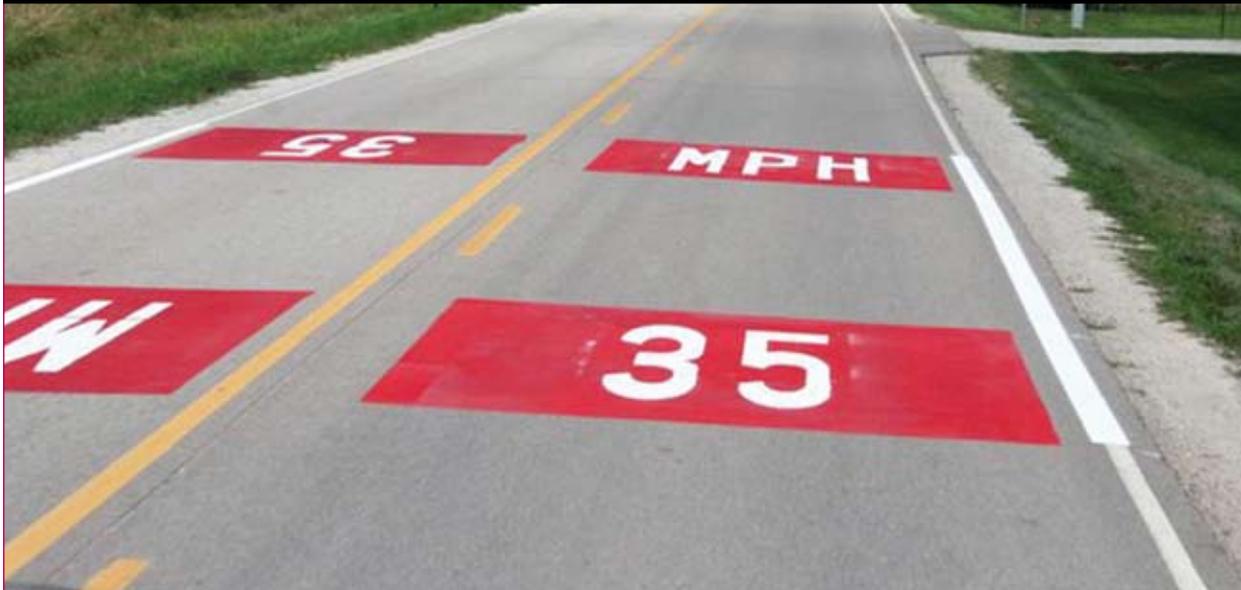
Figure 12. Speed limit markings with experimental red background in Dexter.

Speed limit markings (figure 12) modeled after European entrance treatments using colored pavement were used at the east and west community entrances to Dexter. The treatment was also placed west of the community on a curve just before a steel fabrication plant, as requested by the community. Community members were concerned about the combination of large trucks backing out of the plant and high-speed vehicles approaching the plant after negotiating a horizontal curve. A large red rectangle (9.5 ft by 12 ft) was used to frame the on-pavement "35 MPH" speed limit markings. An 8 inch edgeline was also painted along the treatments to enhance visibility.

As shown in table 9, the treatment was very effective in reducing the speed of traffic entering the community. Speeds downstream of the curve on the western edge of Dexter and at the western entrance decreased from 4 mi/h to 9 mi/h during most analysis periods. The speed reductions at the eastern entrance to Dexter were not as dramatic. This may be due in part to the prevailing speed in the baseline period at the east entrance, which was already lower than the west entrance to the community.
